## Windstorm Mitigation Report (OIR-B1-1802)

East Lake Woodlands Condominium Unit Seven Association, Inc.

201-216 Mary Dr, Bldg 2, 16-Unit Risk

As of 3/1/2023 | FPAT File# MUD2317359

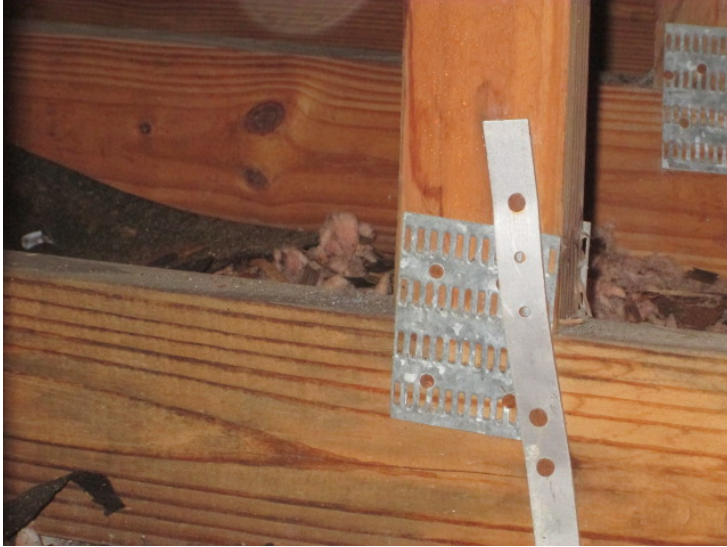
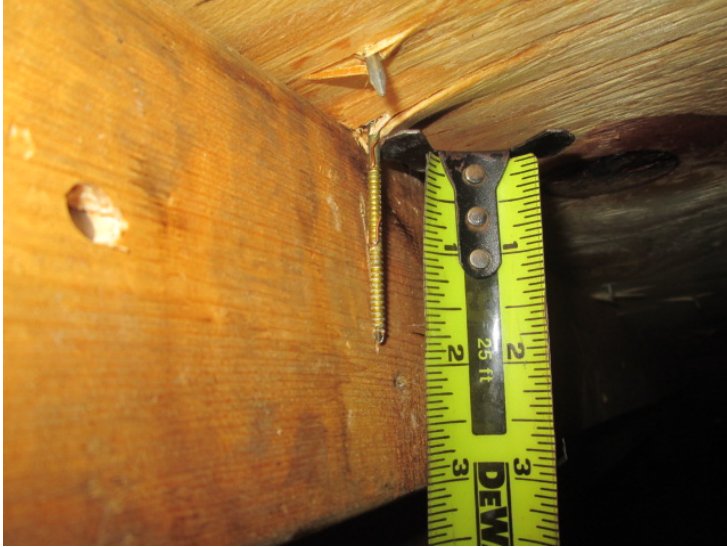
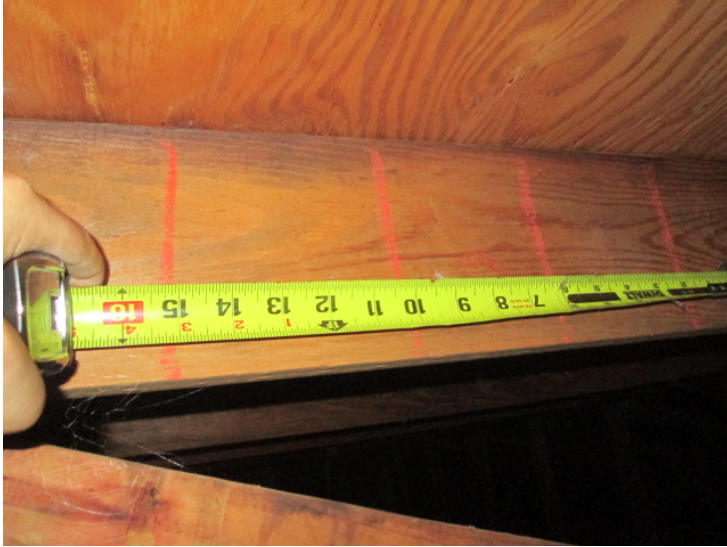
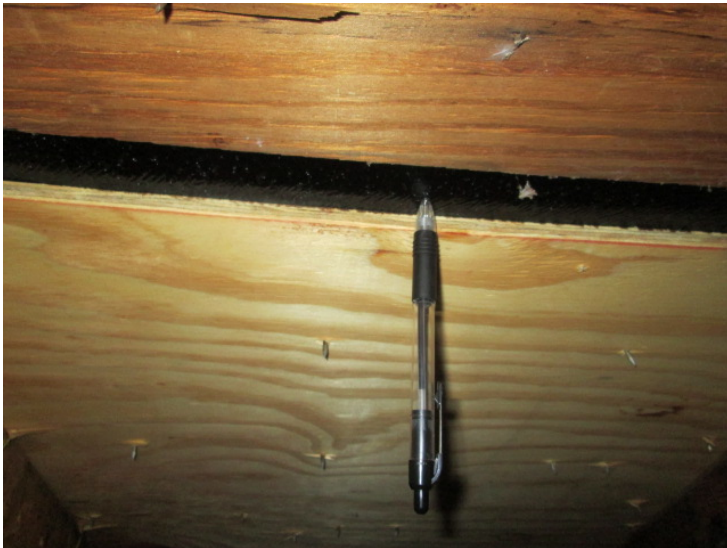
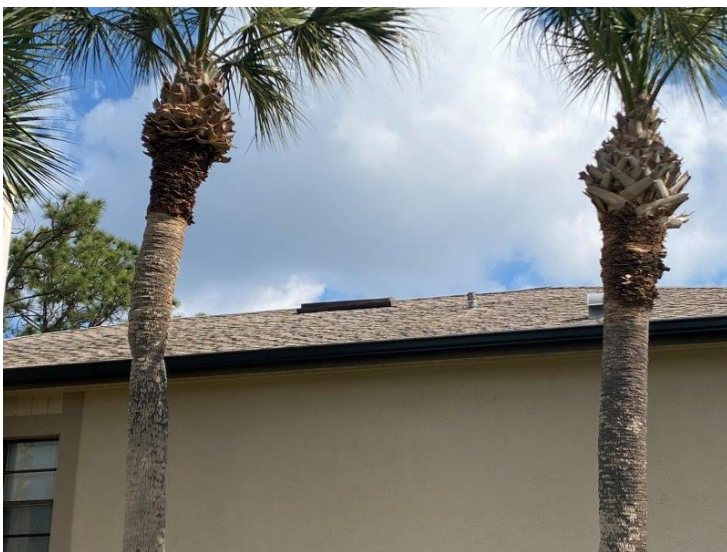
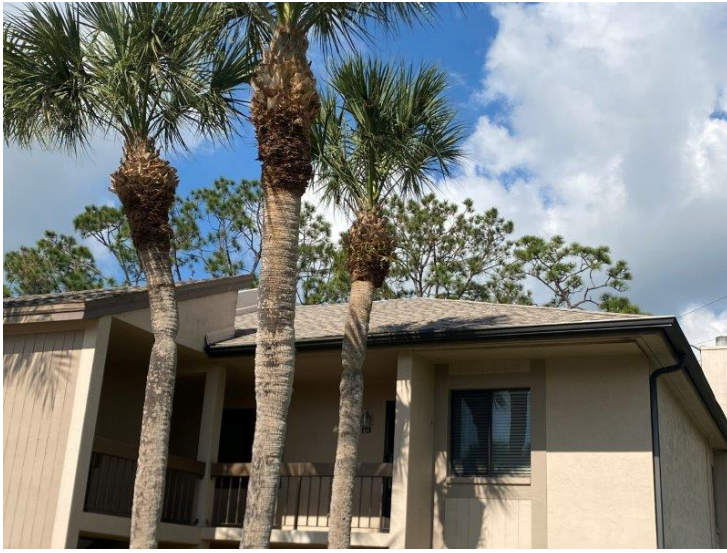
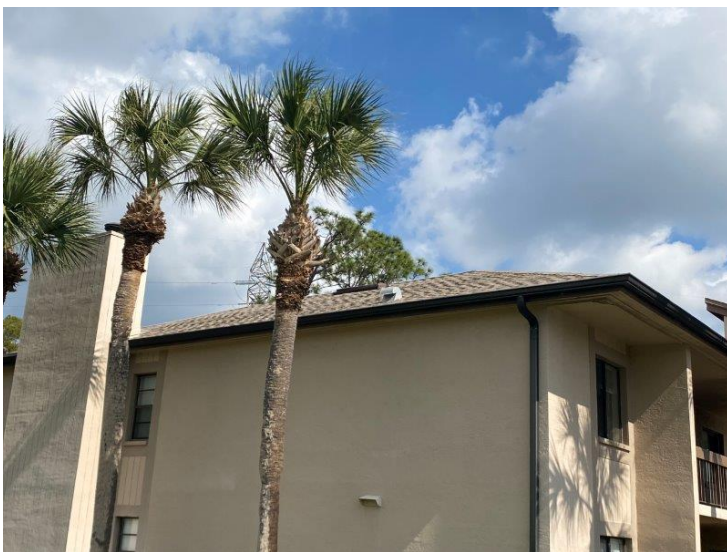
Roof Construction

- 3. Roof Deck Attachment:** **Level C**  
Comments: Inspection verified 1/2" plywood roof deck attached with 8d nails at a minimum 6" on the edge & 6" in the field.

- 4. Roof to Wall Attachment:** **Clips**  
Comments: Inspection verified embedded straps fastened with a minimum of three nails.
- 5. Roof Geometry:** **Other Roof**  
Comments: Inspection verified a combination of pitched and flat roof shapes.

- 6. SWR:** **Yes**  
Comments: SWR was verified at time of inspection. The Secondary Water Resistance verified is a self-adhering peel and stick.
- 7. Opening Protection:** **None or Some Glazed Openings**  
Comments: Inspection verified no opening protection.
