## Windstorm Mitigation Report (OIR-B1-1802)

East Lake Woodlands Condominium Unit Seven Association, Inc.

217-232 Mary Dr, Bldg 3, 16-Unit Risk

As of 3/1/2023 | FPAT File# MUD2317359

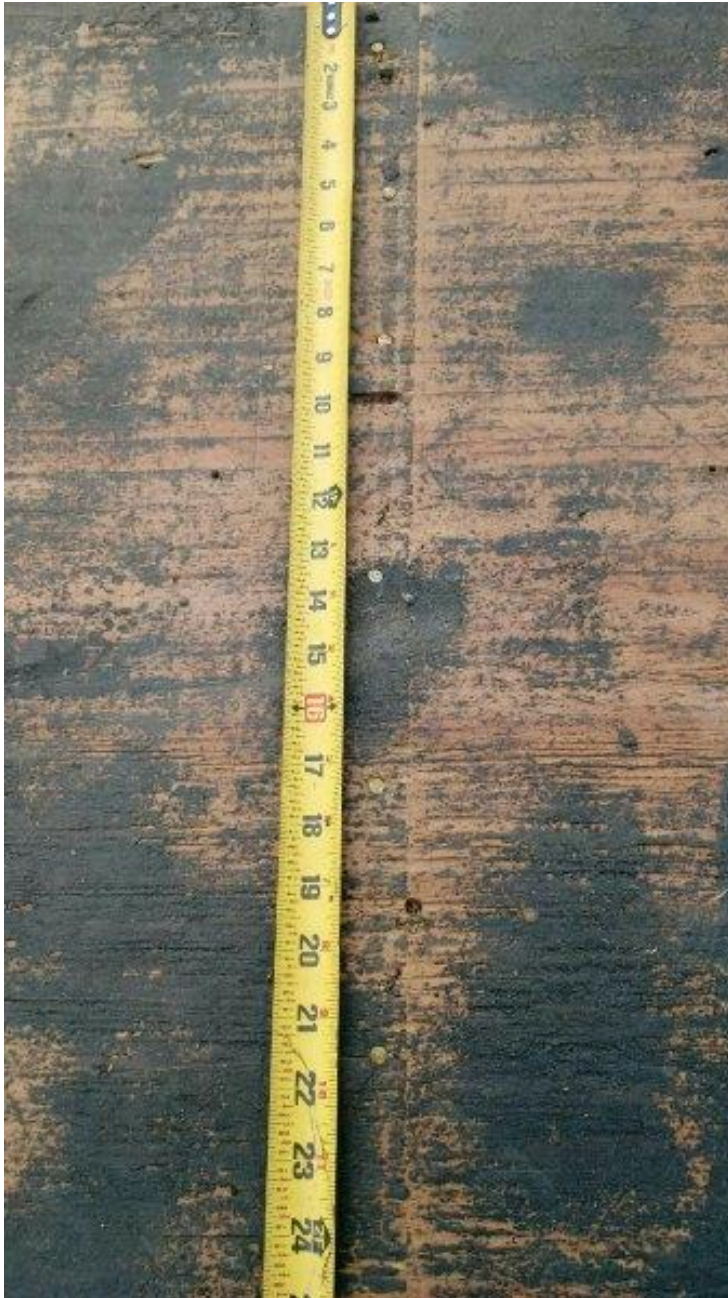
Roof Construction

- 3. Roof Deck Attachment:** **Level C**  
Comments: Inspection verified 1/2" plywood roof deck attached with 8d nails at a minimum 6" on the edge & 6" in the field.

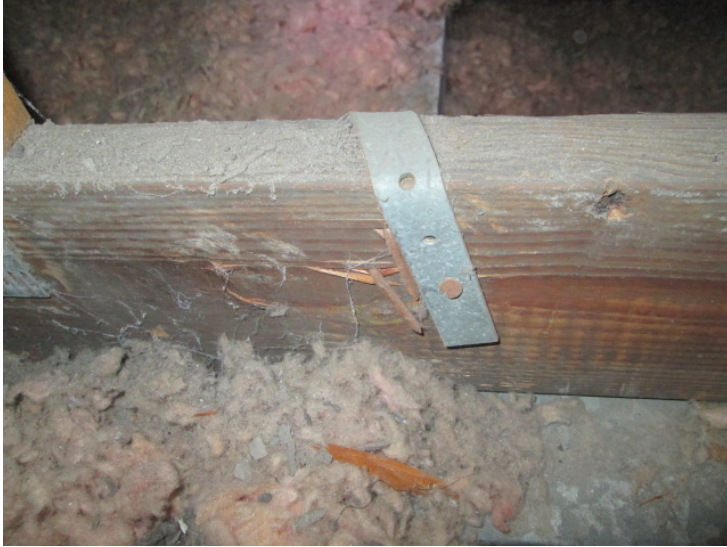
Roof Construction

- 4. Roof to Wall Attachment:** **Single Wraps**  
Comments: Single wraps were verified during our attic inspection as the roof wall connection. Each single wrap has a minimum of two nails on the front of the truss and one nail on the opposite side.
