Windstorm Mitigation Report (OIR-B1-1802)

East Lake Woodlands Condominium Unit Seven Association, Inc.

101-116 Camille Ct, Bldg 4, 16-Unit Risk

As of 3/1/2023 | FPAT File# MUD2317359

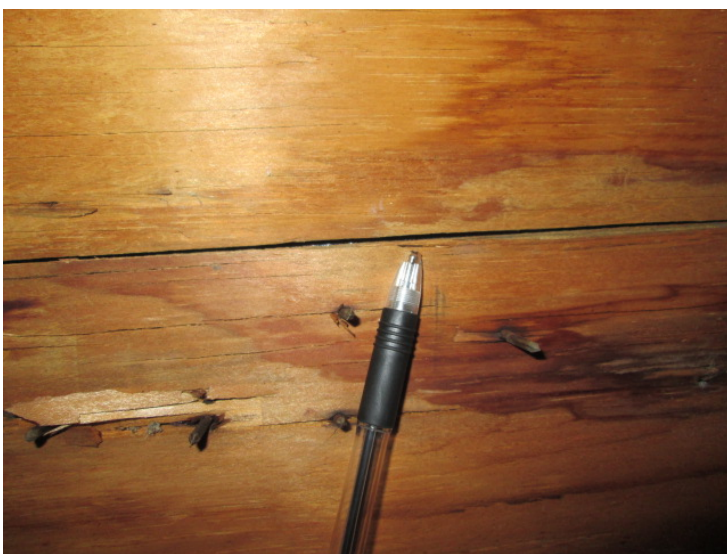
Roof Construction

- 3. Roof Deck Attachment:** **Level C**
Comments: Inspection verified 1/2" plywood roof deck attached with 8d nails at a minimum 6" on the edge & 6" in the field.

- 4. Roof to Wall Attachment:** **Clips**
Comments: Inspection verified embedded straps fastened with a minimum of three nails.
- 5. Roof Geometry:** **Other Roof**
Comments: Inspection verified a combination of pitched and flat roof shapes.

- 6. SWR:** **Yes**
Comments: SWR was verified at time of inspection. The Secondary Water Resistance verified is a self-adhering peel and stick.
- 7. Opening Protection:** **None or Some Glazed Openings**
Comments: Inspection verified no opening protection.
