Windstorm Mitigation Report (OIR-B1-1802)

East Lake Woodlands Condominium Unit Seven Association, Inc.

101-112 Woodland Ct, Bldg 6, 12-Unit Risk

As of 3/1/2023 | FPAT File# MUD2317359

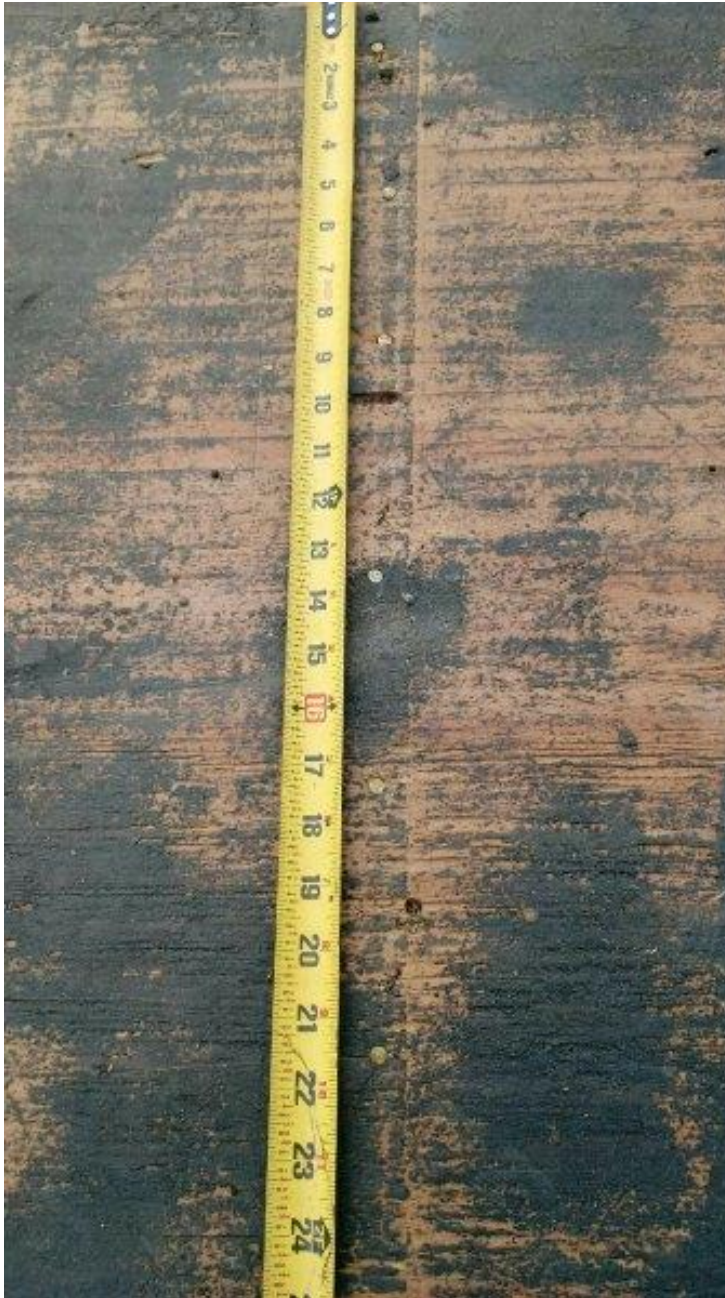
Roof Construction

- 3. Roof Deck Attachment:** **Level C**
Comments: Inspection verified 1/2" plywood roof deck attached with 8d nails at a minimum 6" on the edge & 6" in the field.

- 4. Roof to Wall Attachment:** **Clips**
Comments: Inspection verified embedded straps fastened with a minimum of three nails.
- 5. Roof Geometry:** **Other Roof**
Comments: Inspection verified a combination of pitched and flat roof shapes.

- 6. SWR:** **Yes**
Comments: SWR was verified at time of inspection. The Secondary Water Resistance verified is a self-adhering peel and stick.
- 7. Opening Protection:** **None or Some Glazed Openings**
Comments: Inspection verified no opening protection.
