Windstorm Mitigation Report (OIR-B1-1802)

East Lake Woodlands Condominium Unit Seven Association, Inc.
101 Camille Ct. Pool Restroom Bldg.
Oldsmar, FL 34677

As of 06-07-2024 | FPAT File# MIT2422636

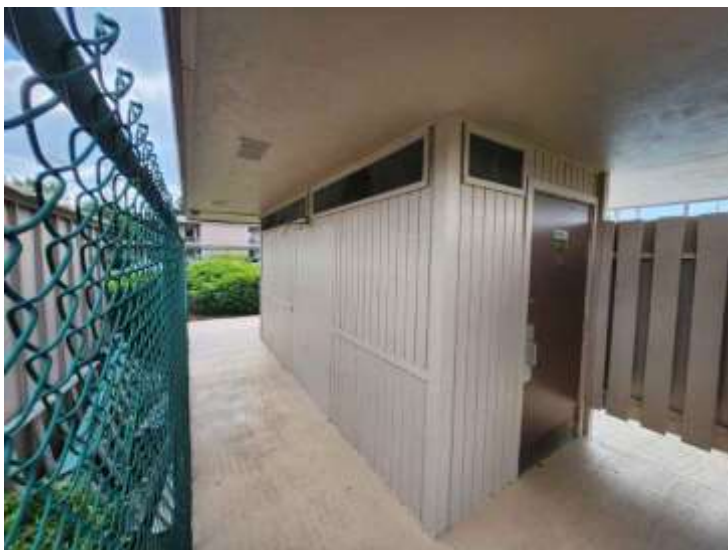
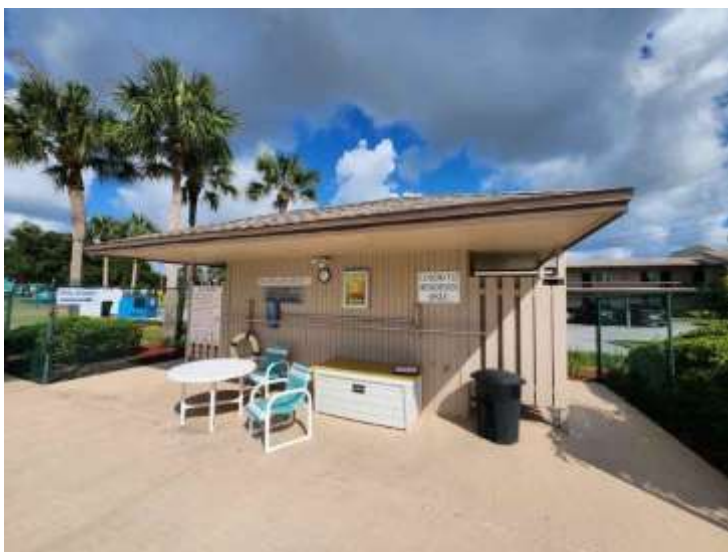
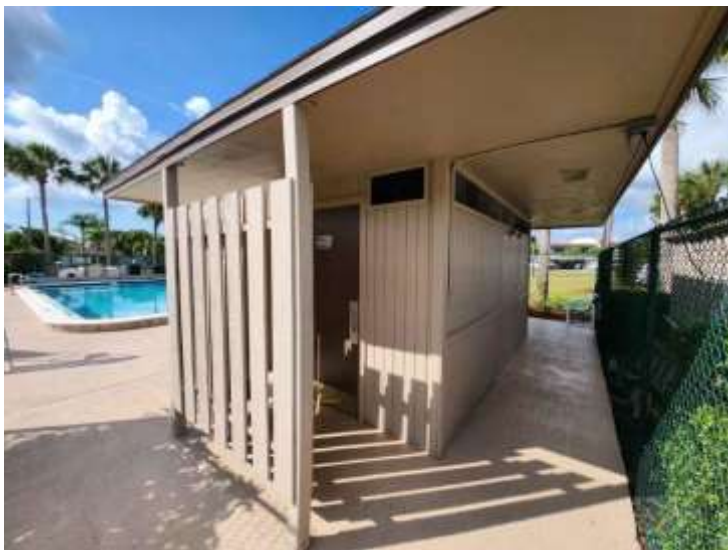
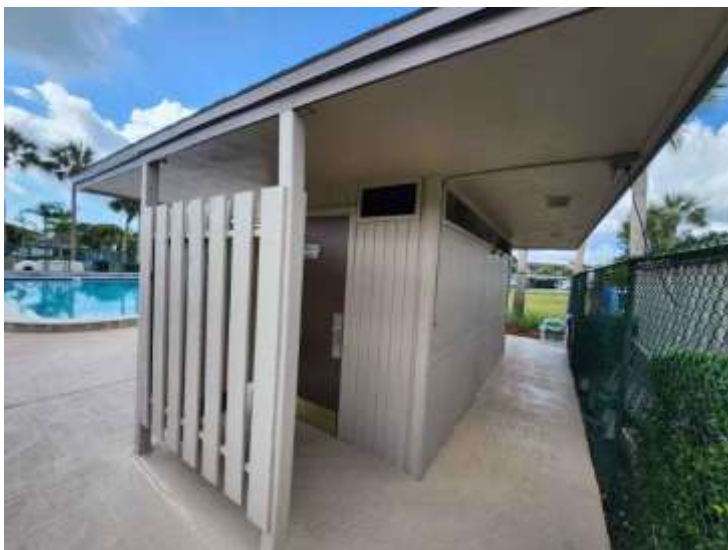
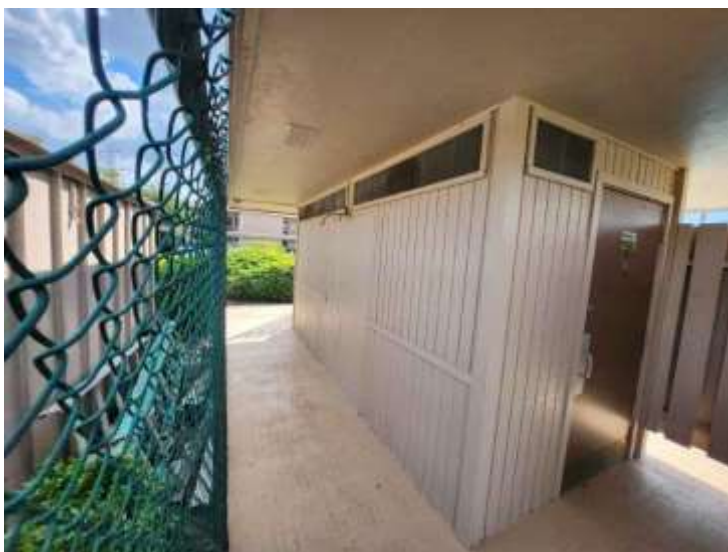
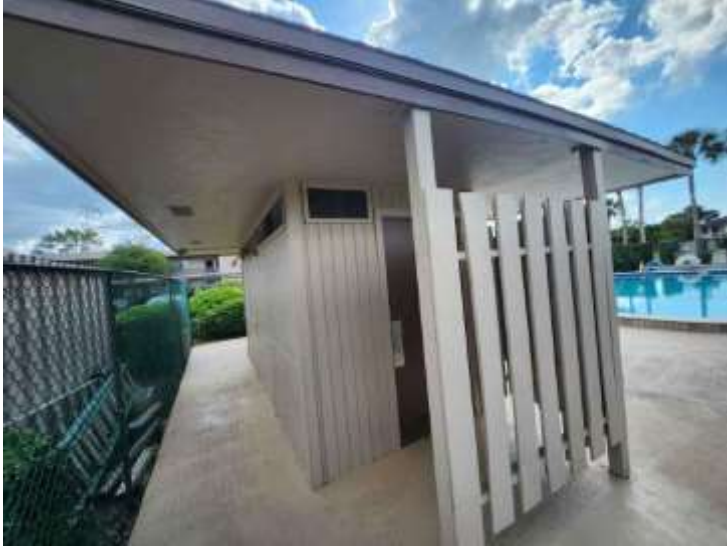
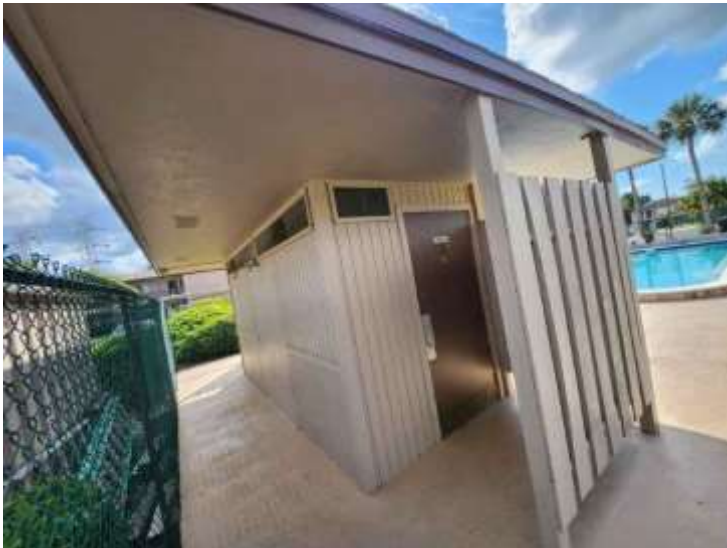
Exterior Elevation

- 4. Roof to Wall Attachment:** **Clips**
Comments: Inspection verified hurricane clips fastened with a minimum of three nails.
- 5. Roof Geometry:** **Hip Roof**
Comments: Inspection verified a hip roof shape.

- 6. SWR:** **Yes**
Comments: SWR was verified at time of inspection. The Secondary Water Resistance verified is a self-adhering peel and stick.
- 7. Opening Protection:** **None or Some Glazed Openings**
Comments: Inspection verified some opening protection. Not all glazed openings were protected with impact resistant coverings.

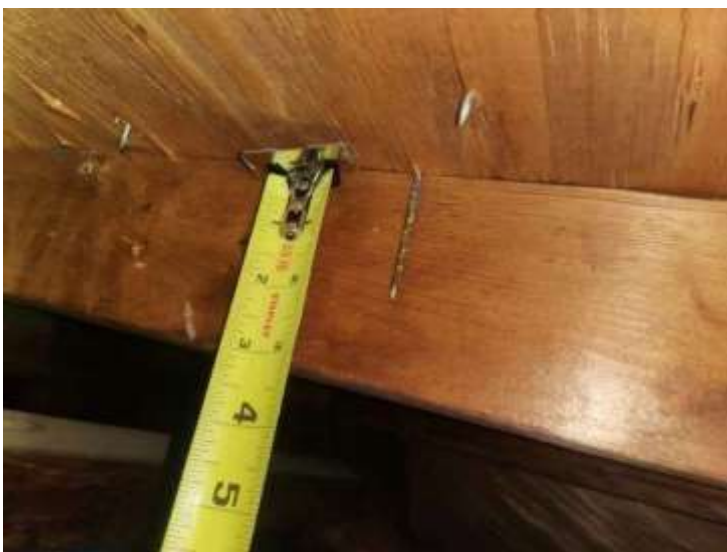
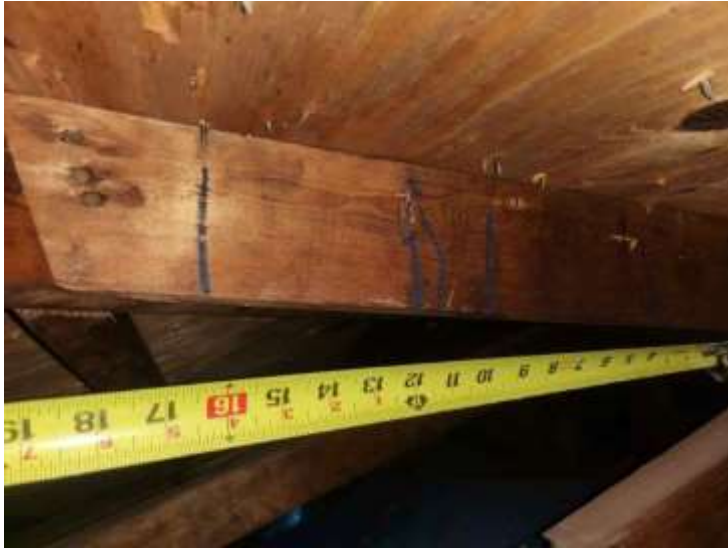
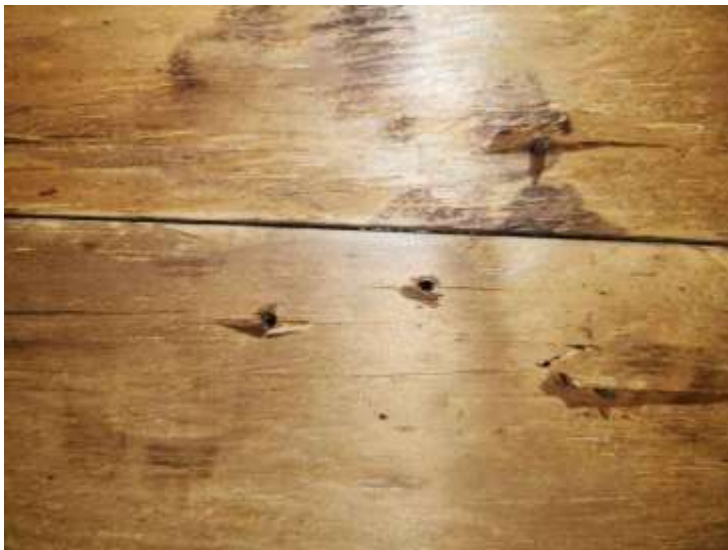
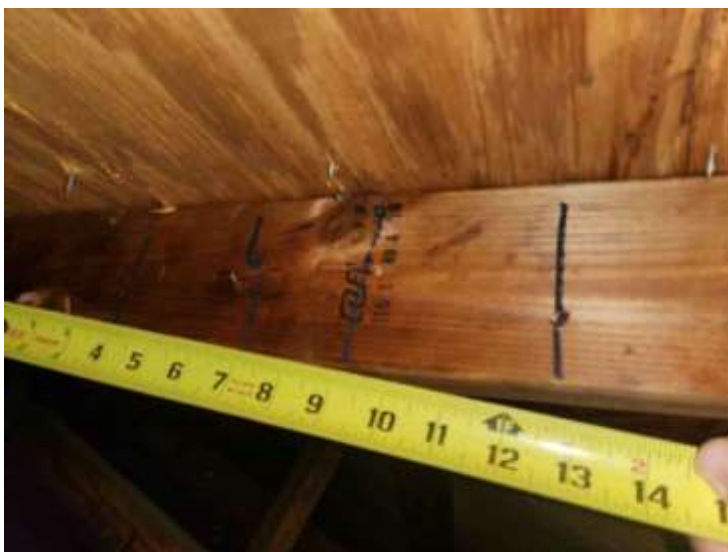
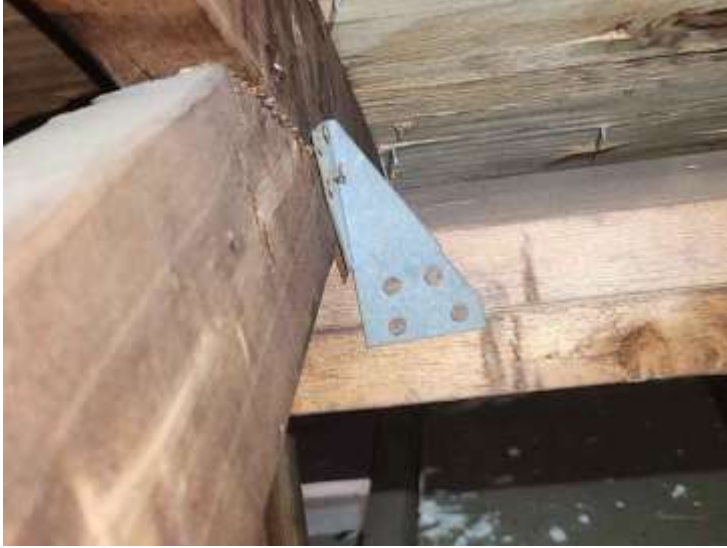
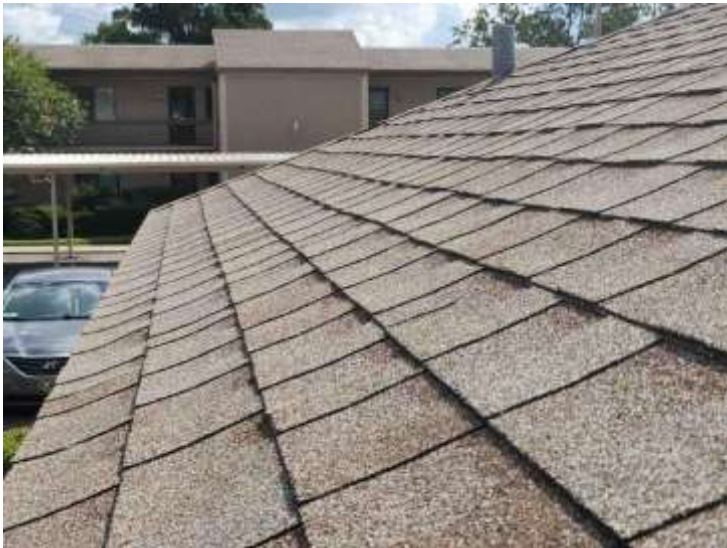
Roof Construction

- 3. Roof Deck Attachment:** **Level C**
Comments: Inspection verified 1/2" plywood roof deck attached with 8d nails at a minimum 6" on the edge & 6" in the field.

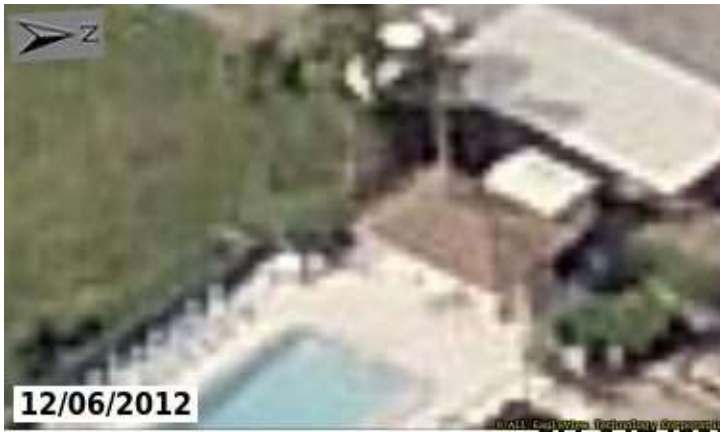
Supporting
Documentation

- 2. Roof Covering:** **FBC Equivalent**
Comments: According to association records the roof covering was replaced between 2012-2014. We were unable to locate a roofing permit with the local building department; however, in our professional opinion the roof covering was replaced between 2012-2014. The roof covering replacement was confirmed via historical imagery provided by Pictometry and information provided by the association.
